Cleaning of Urea Strippers and Recirculation Heaters

Removal of deposits greatly enhances efficiency and capacity

Urea Stripper Cleaning Project:

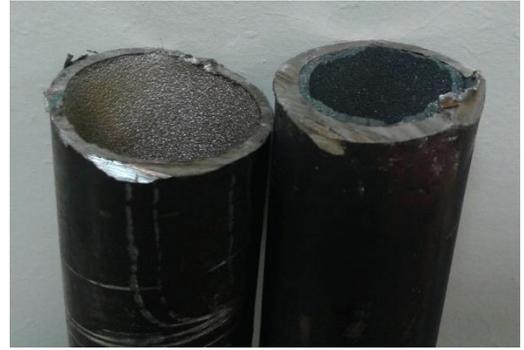
The total amount of iron-oxides removed was 1,800 kg as iron. The cleaning result was more than satisfactory and the loss in production was totally nullified after the commissioning of the plant. Photo 1 shows the typical fouling of the Urea Stripper in the bottom part of the tubes (blueish scales).

Photo 1 – typical fouling of the Urea Stripper

At a urea plant in Roemenia, Vecom performed a Urea Stripper cleaning. The Urea Stripper was fouled to the point that it was reducing the stripper efficiency and significantly limiting the plant capacity. Based on the estimated amount of iron oxide scaling and the design parameters, Vecom calculated the amount of EDTA required.
