# Rouging – cleaning and removal

Rouge formation can cause corrosion problems on stainless steel

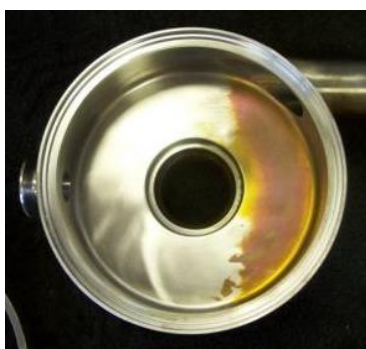
*Pump casing after (partially treated)*

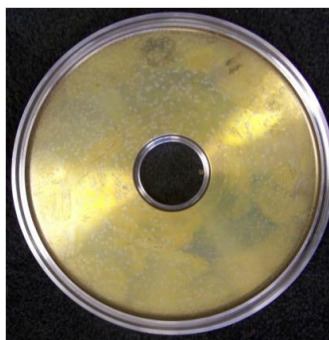
Cover plate before

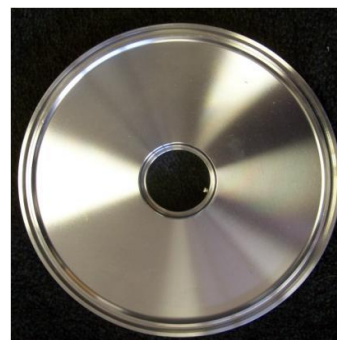
Cover plate after

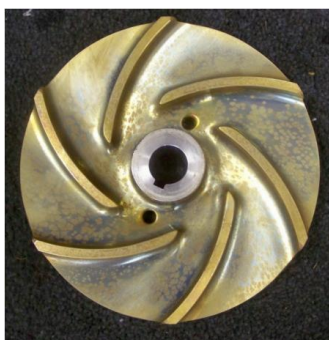
Impeller Plate before

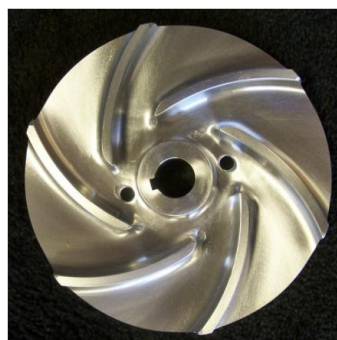
Impeller Plate after
