# Rouging – cleaning and removal

Rouge formation can cause corrosion problems on stainless steel

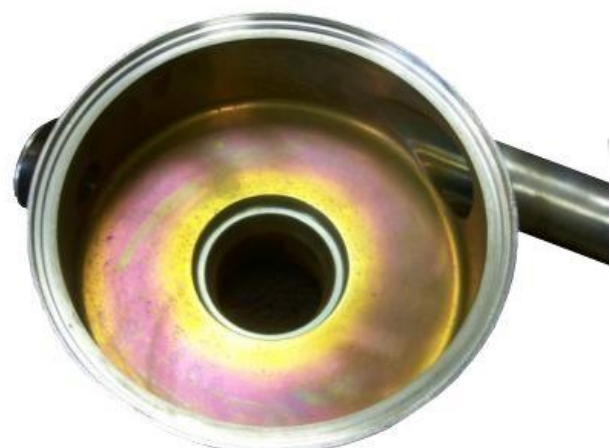
*Pump casing with rouging before treatment*

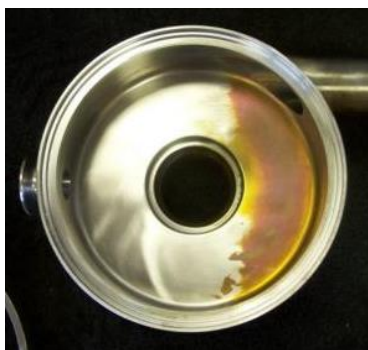
*Pump casing after (partially treated)*

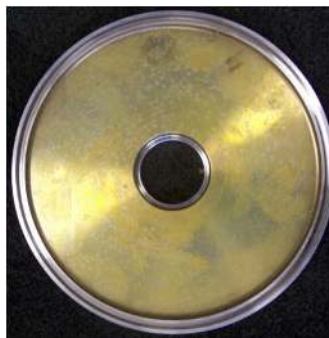
Cover plate before

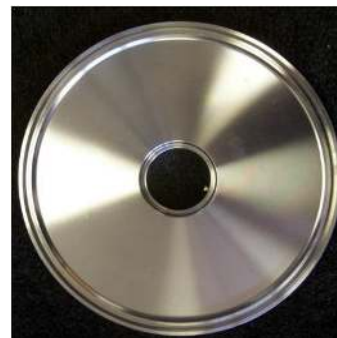
Cover plate after

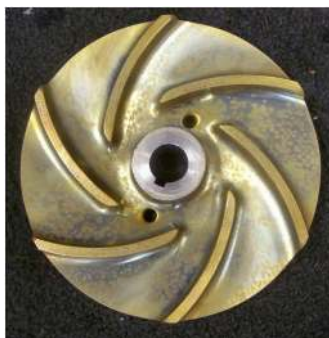
Impeller Plate before

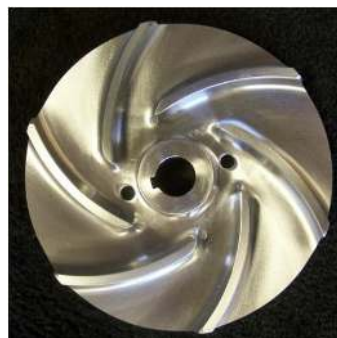
Impeller Plate after
